Situation Photo Log

Friday, October 5, 2012

Kalamazoo River / Enbridge Spill

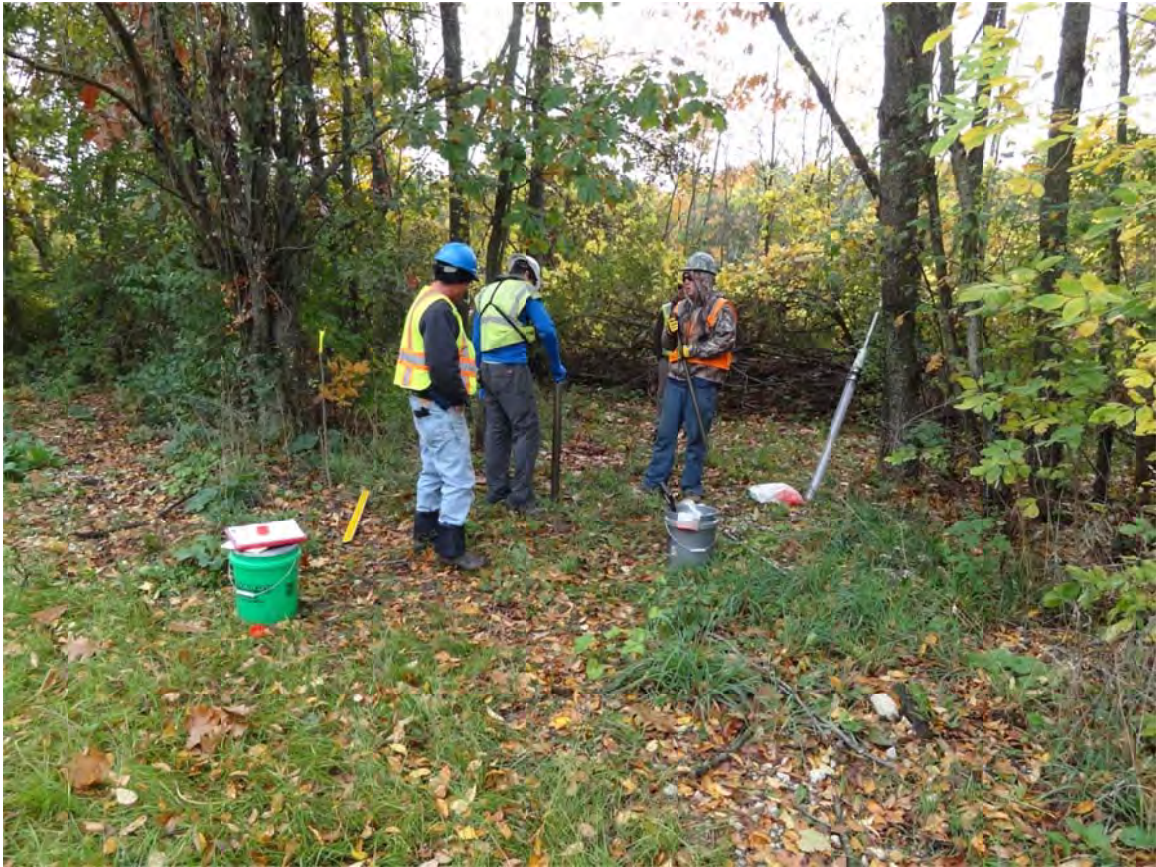
1. C0.4 boat launch, RI Crews collecting soil sample just east of the C0.4 boat launch.

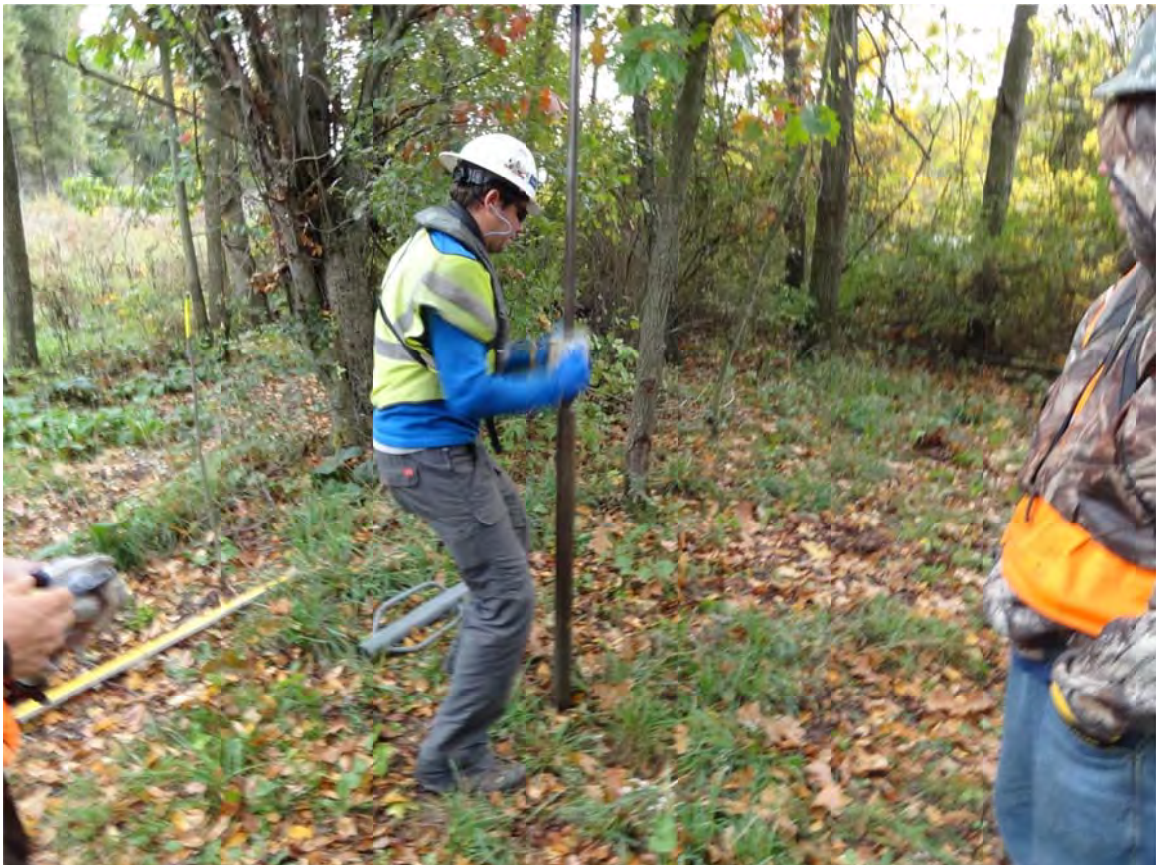
2. RI crew driving soil core sampler near C0.4 boat launch.

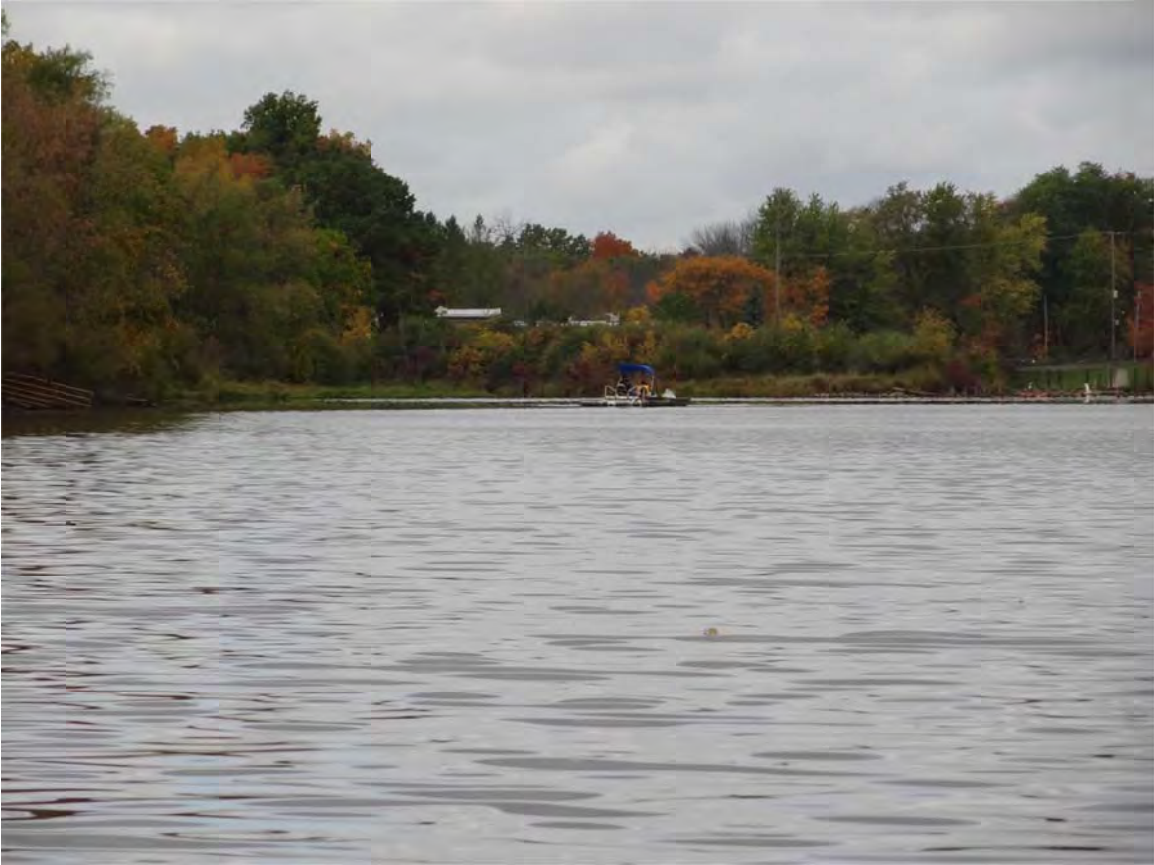
3. MP 5.6 LDB, sheen sweeper boat observed operating upstream of trestle.

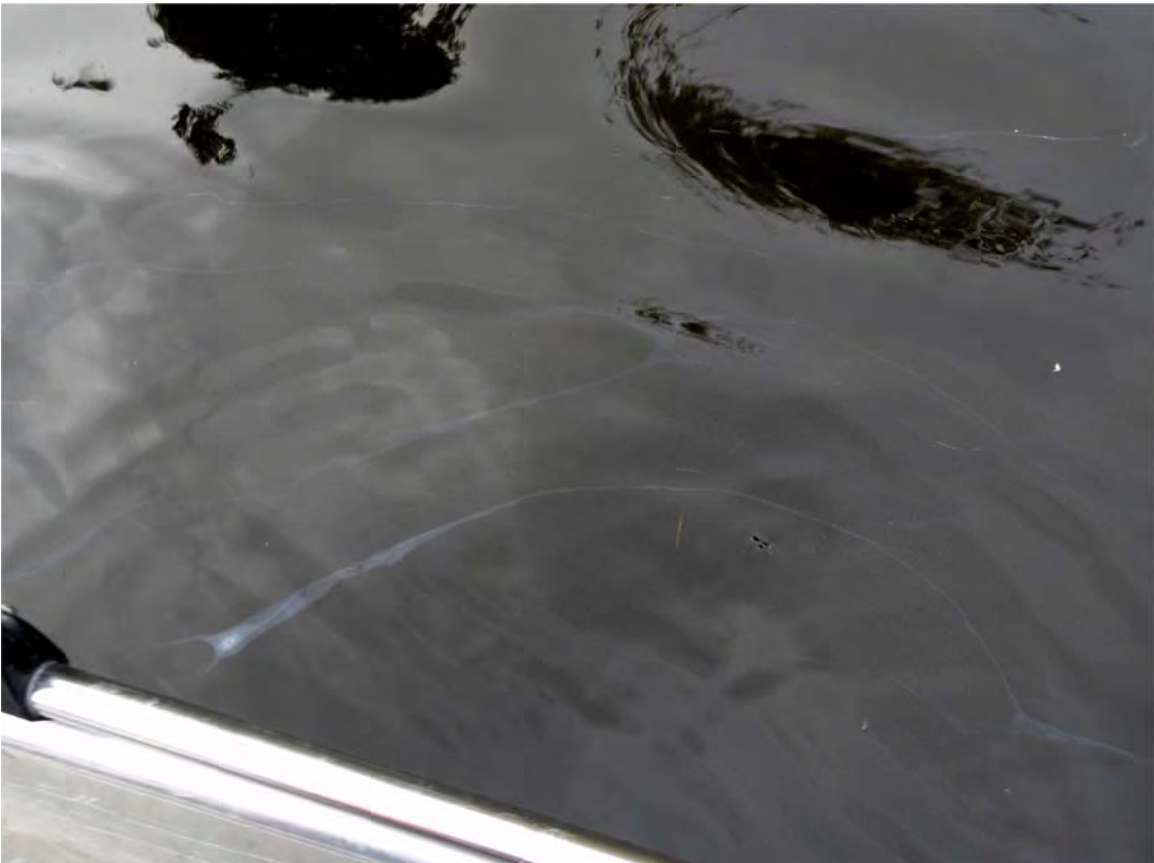
4. MP 5.6 LDB, sheen and tar globules observed along LDB.

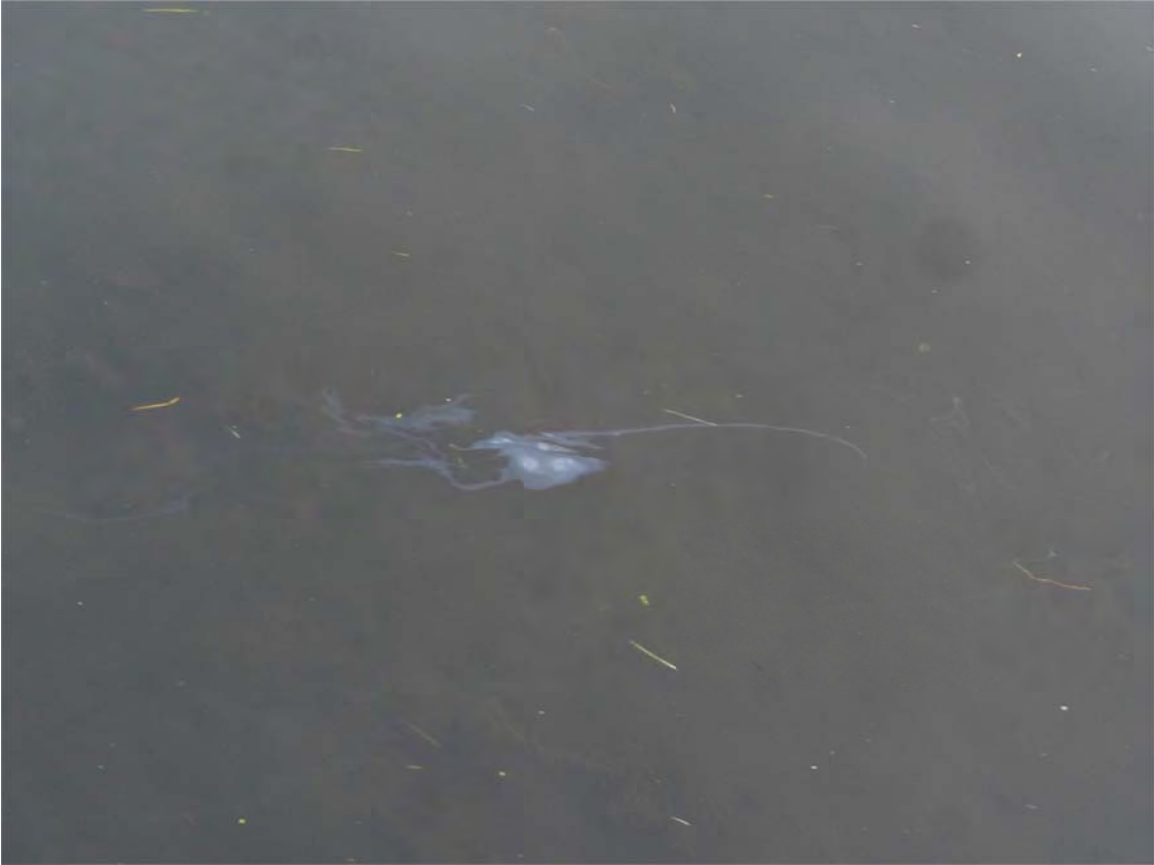
5. MP 5.63 RDB, sheen and tar globules observed upstream of trestle near pyramids.

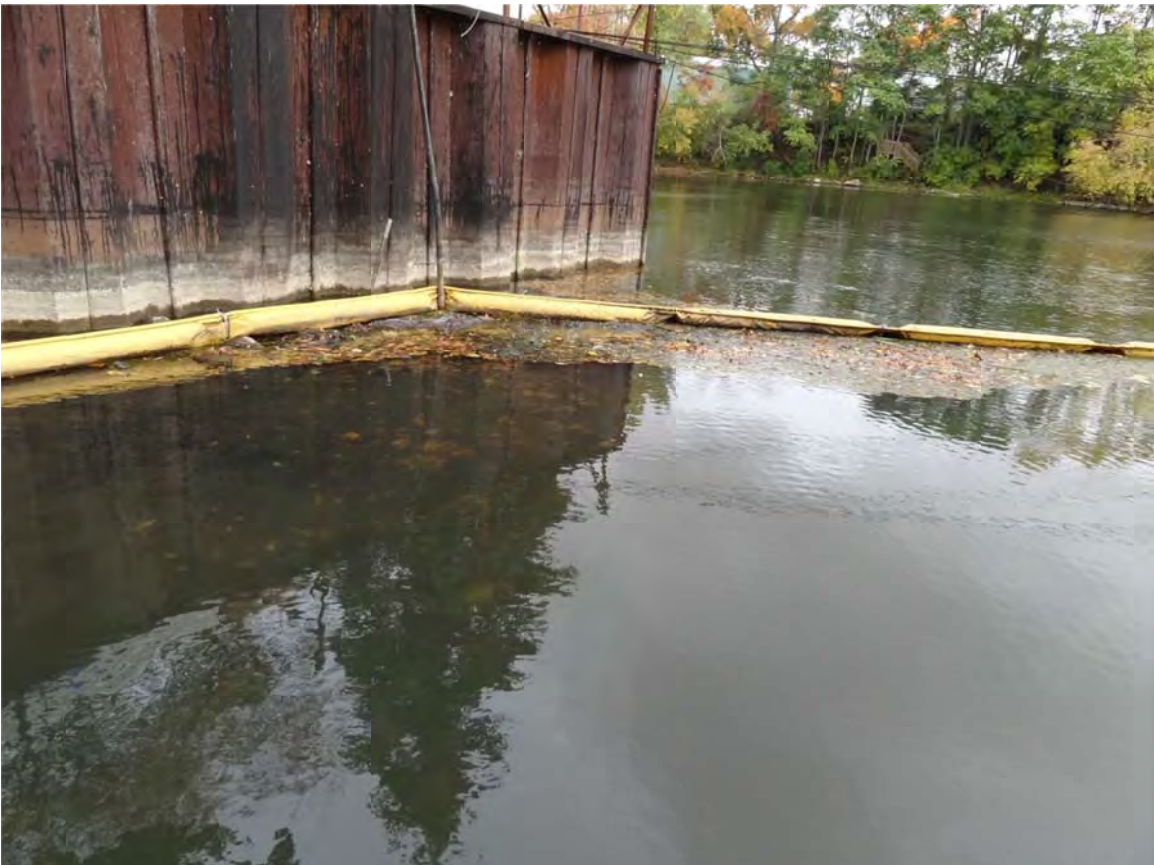
6. Ceresco control point. Crews were in process of removing debris at time of inspection.

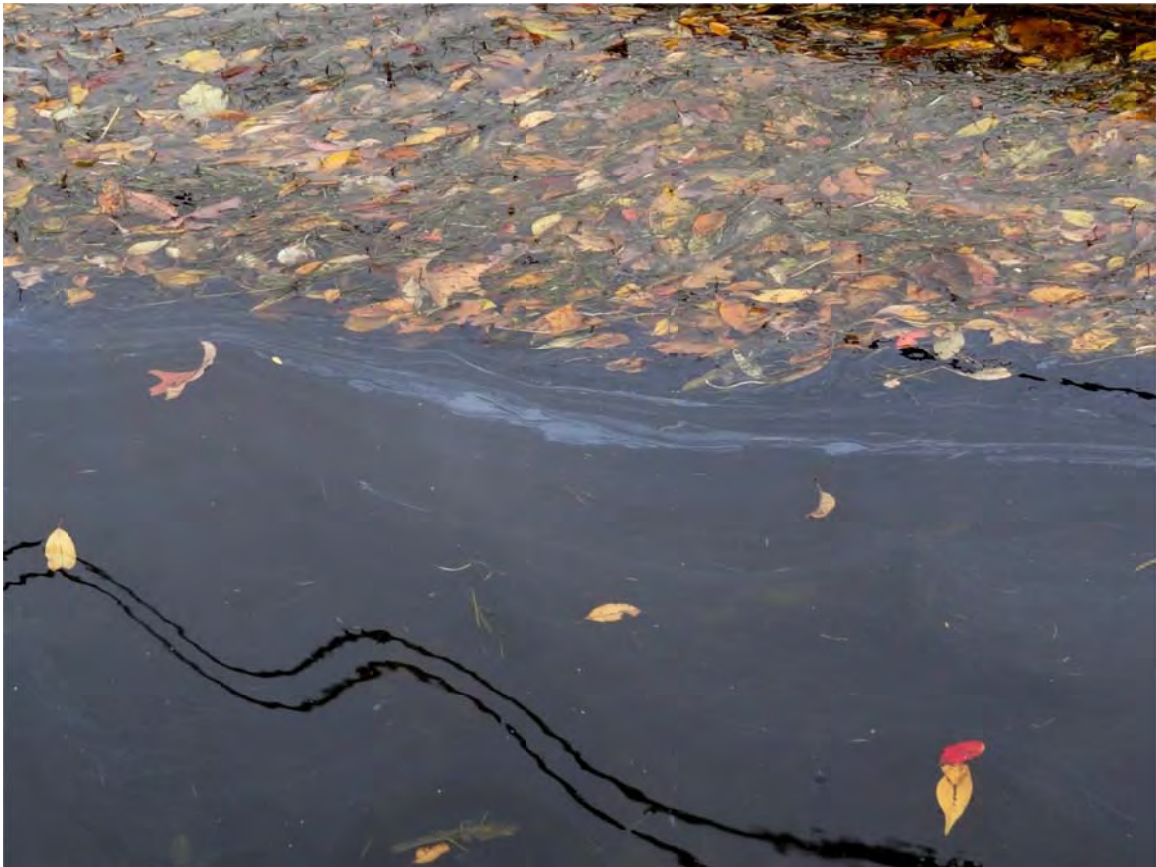
7. MP 5.75, sheen observed within debris along Ceresco containment boom.

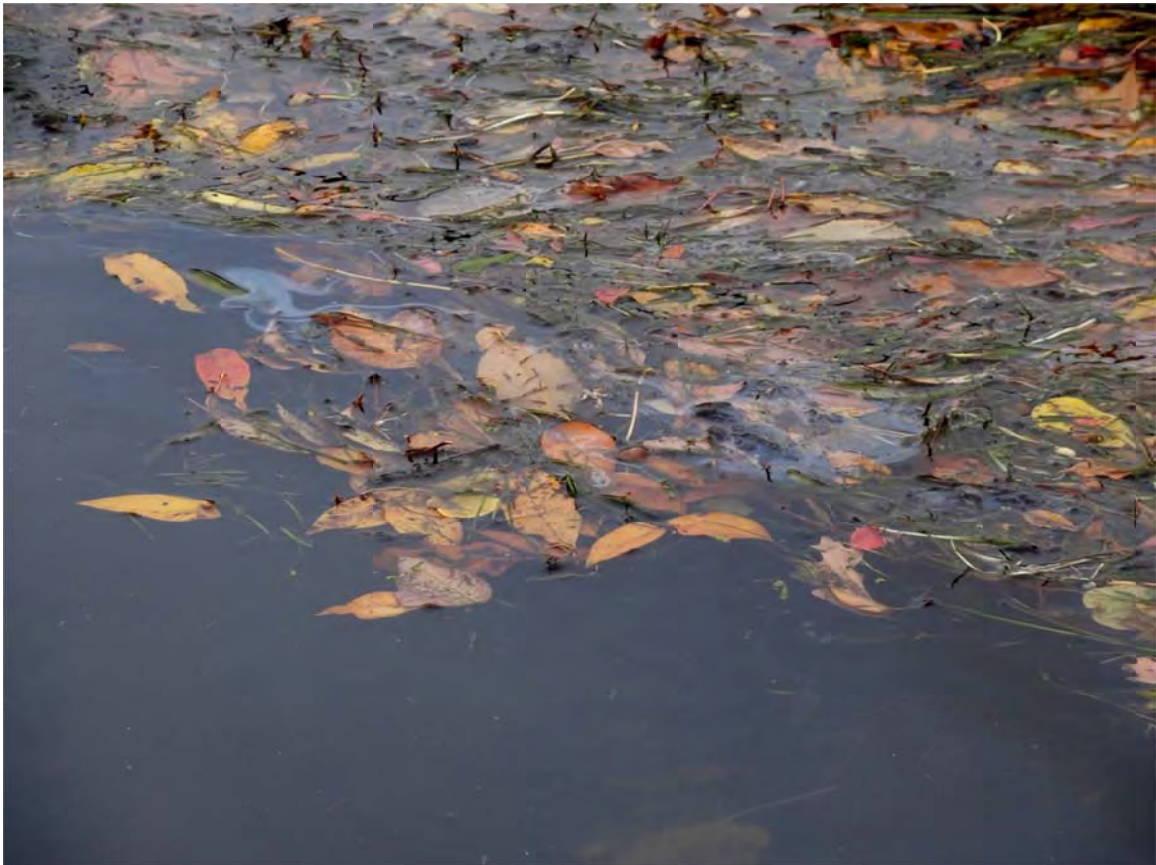
8. MP 5.75, sheen observed within debris along Ceresco containment boom.

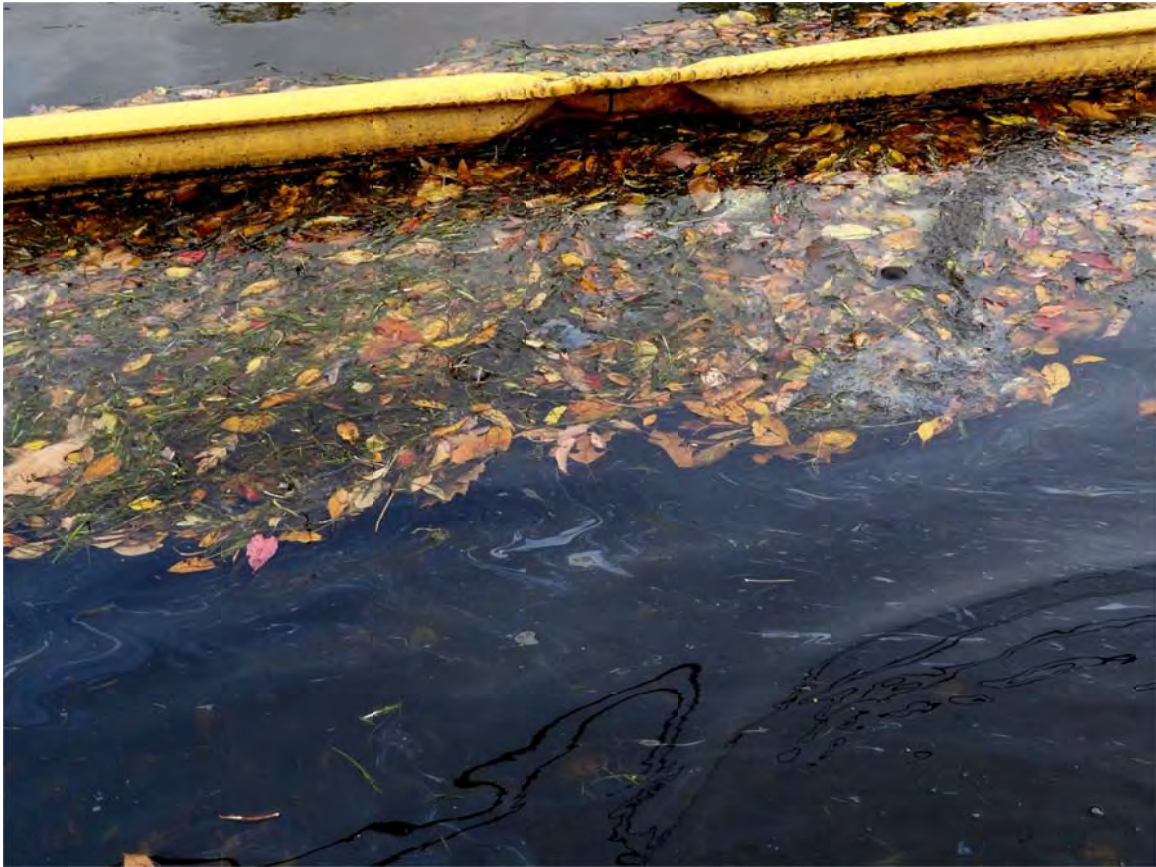
9. Sheen ribbons and tar globules observed along Ceresco Dam control point.

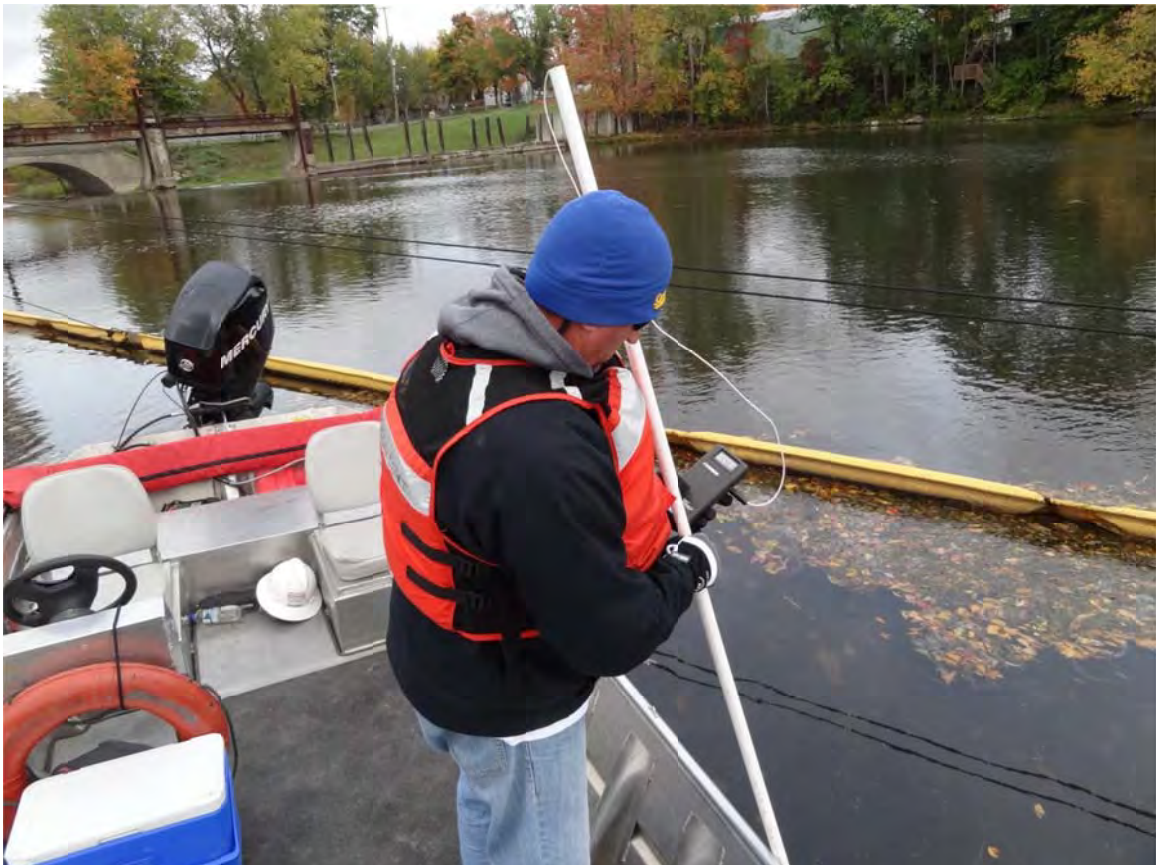
10. Situation unit collecting water & sediment temperatures along Ceresco Dam containment boom.

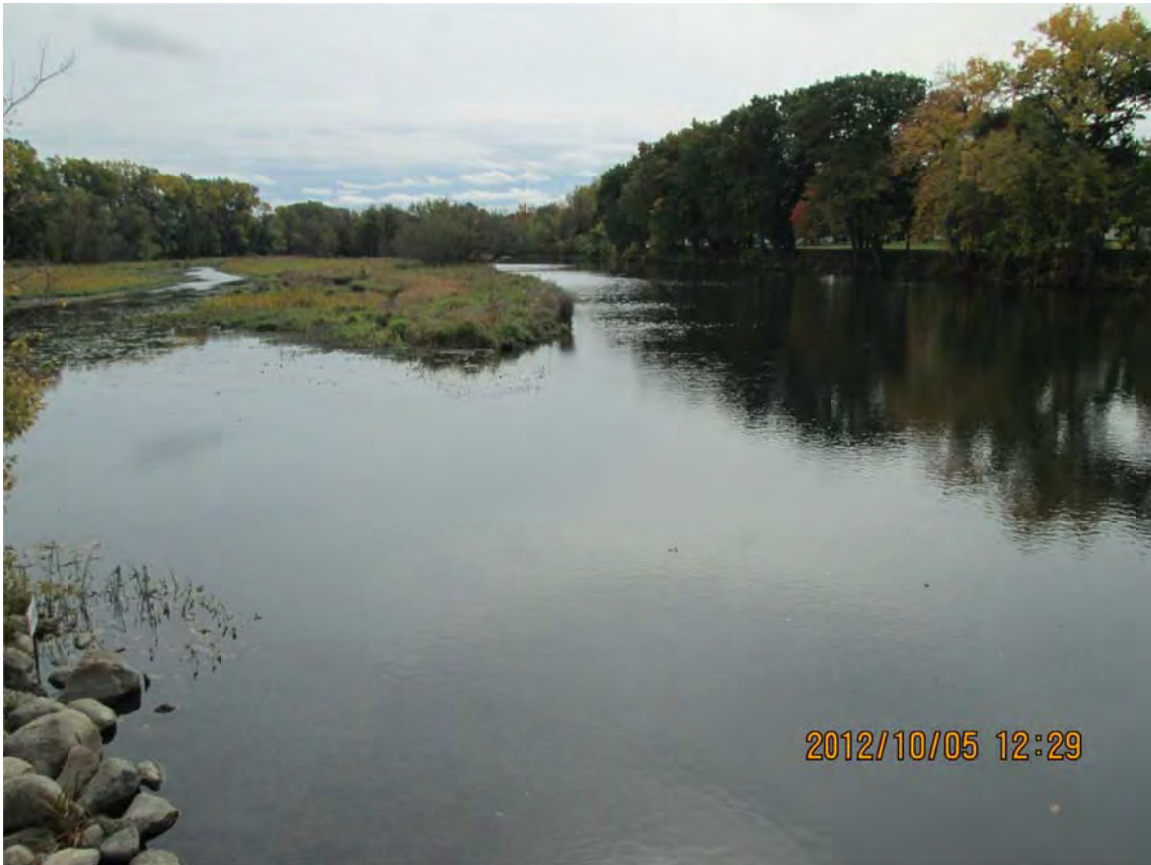
11. MP 15.5 south Mill Pond. No sheen or tar globules observed.

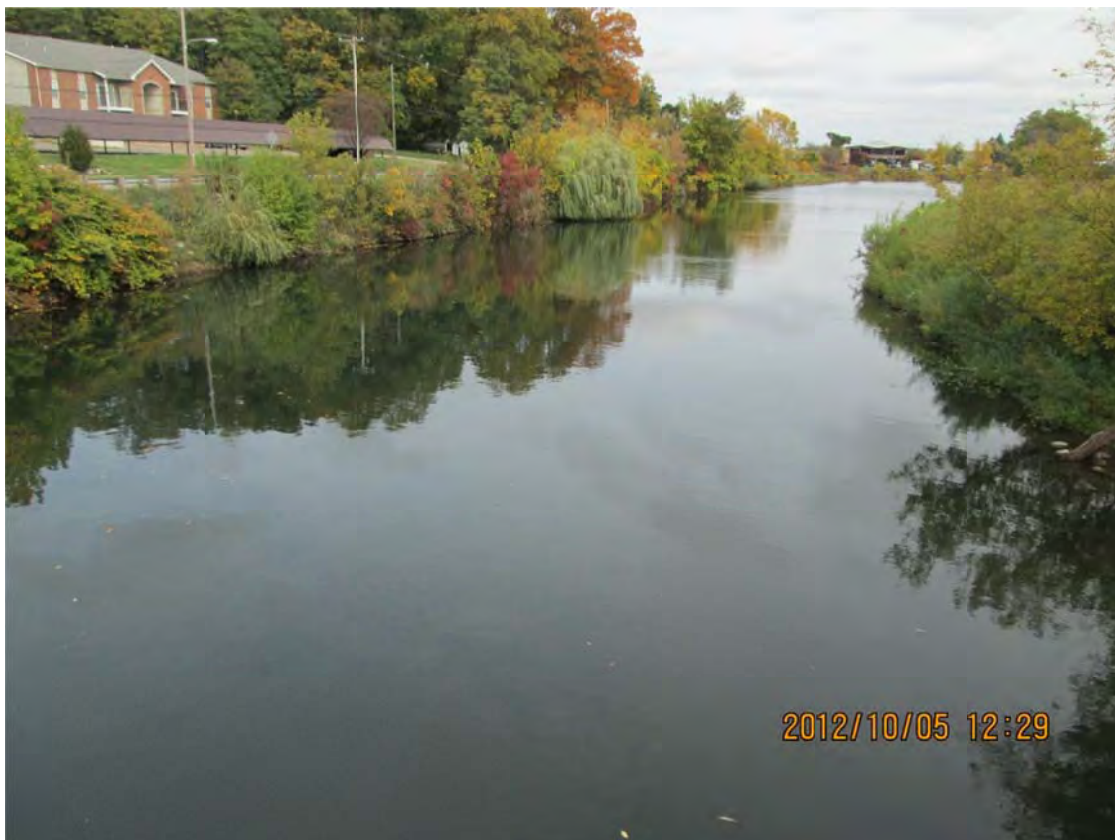
12. River channel at North Mill Pond. No sheen observed.

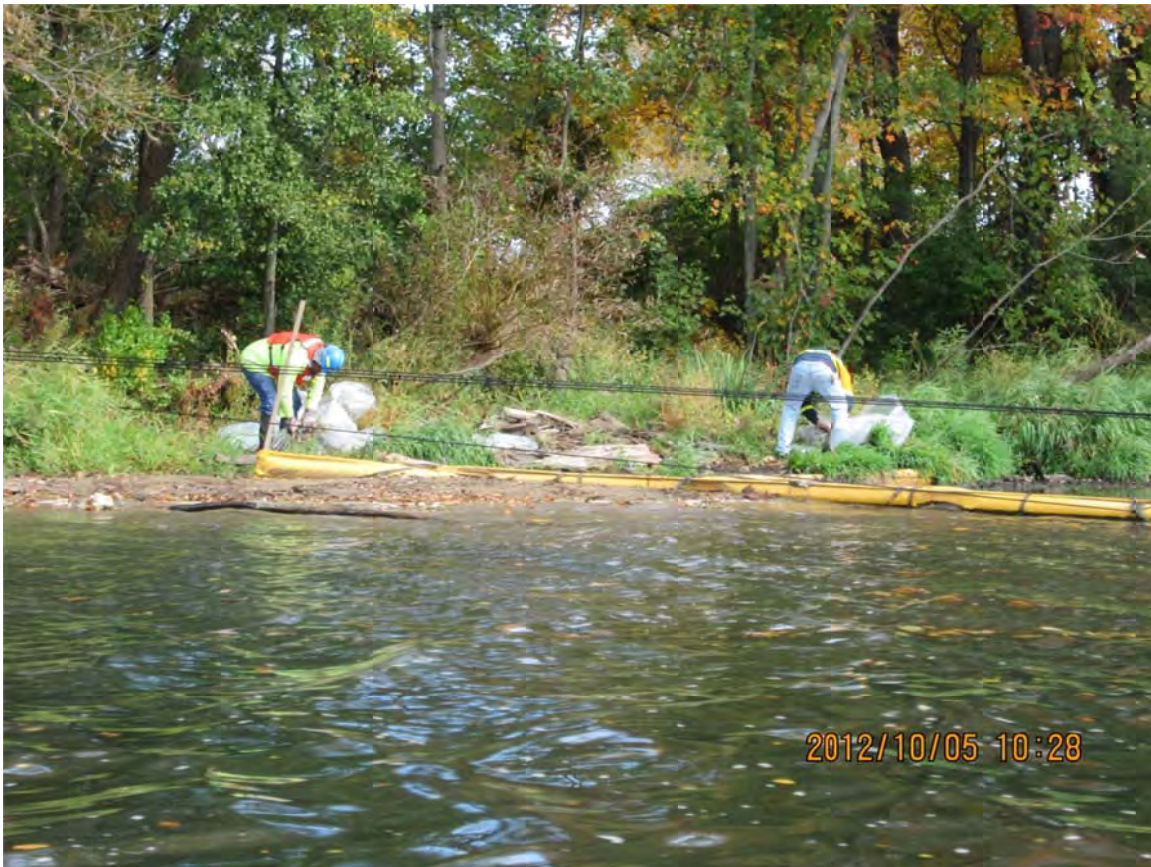
13. Crews removing debris from E4.0 control point.

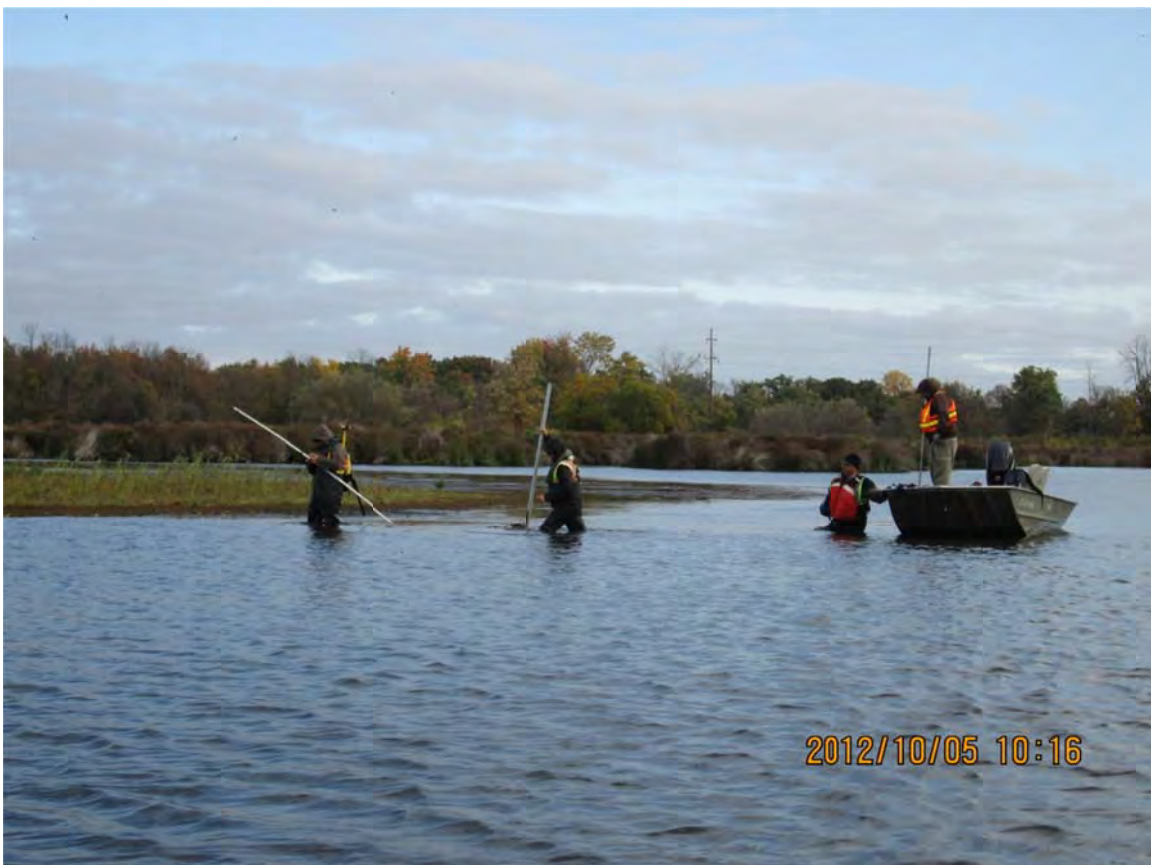
14. Poling crew operating in Delta Z in Morrow Lake Delta.

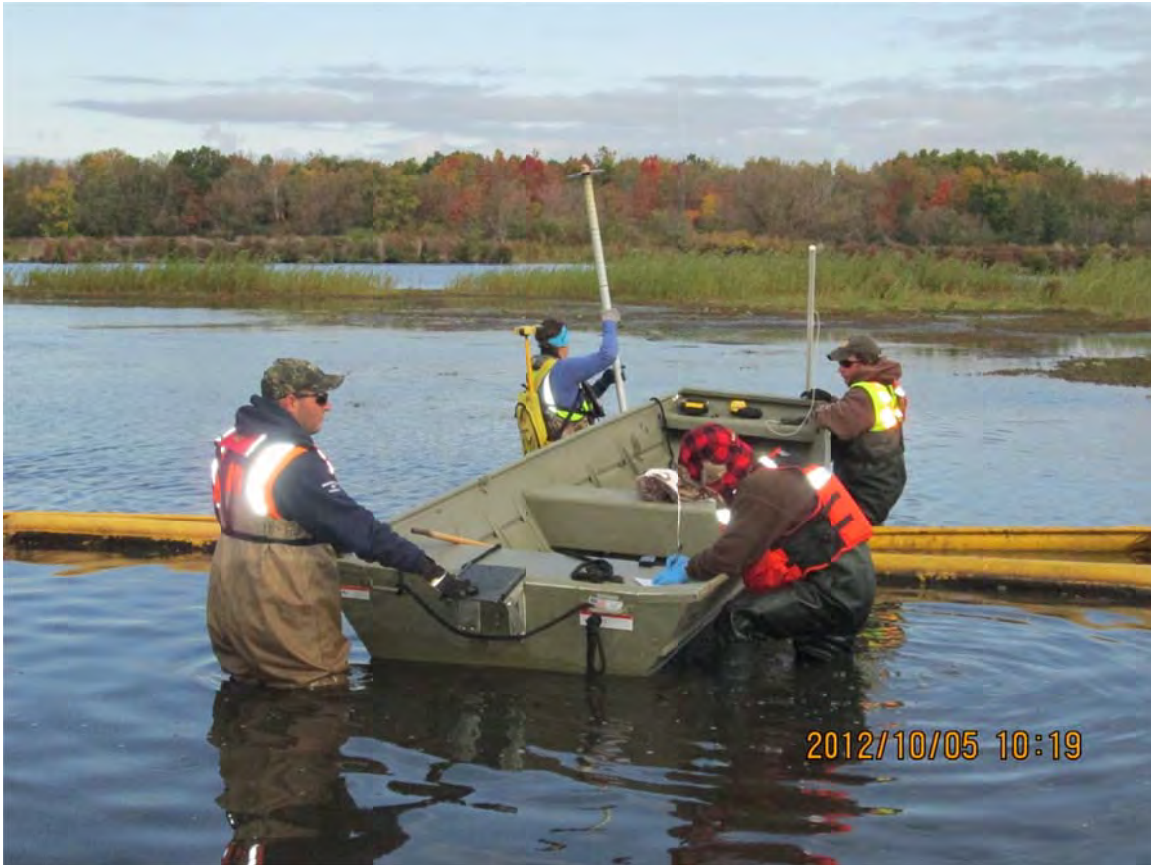
15. Poling crew operating in Delta Z in Morrow Lake Delta.

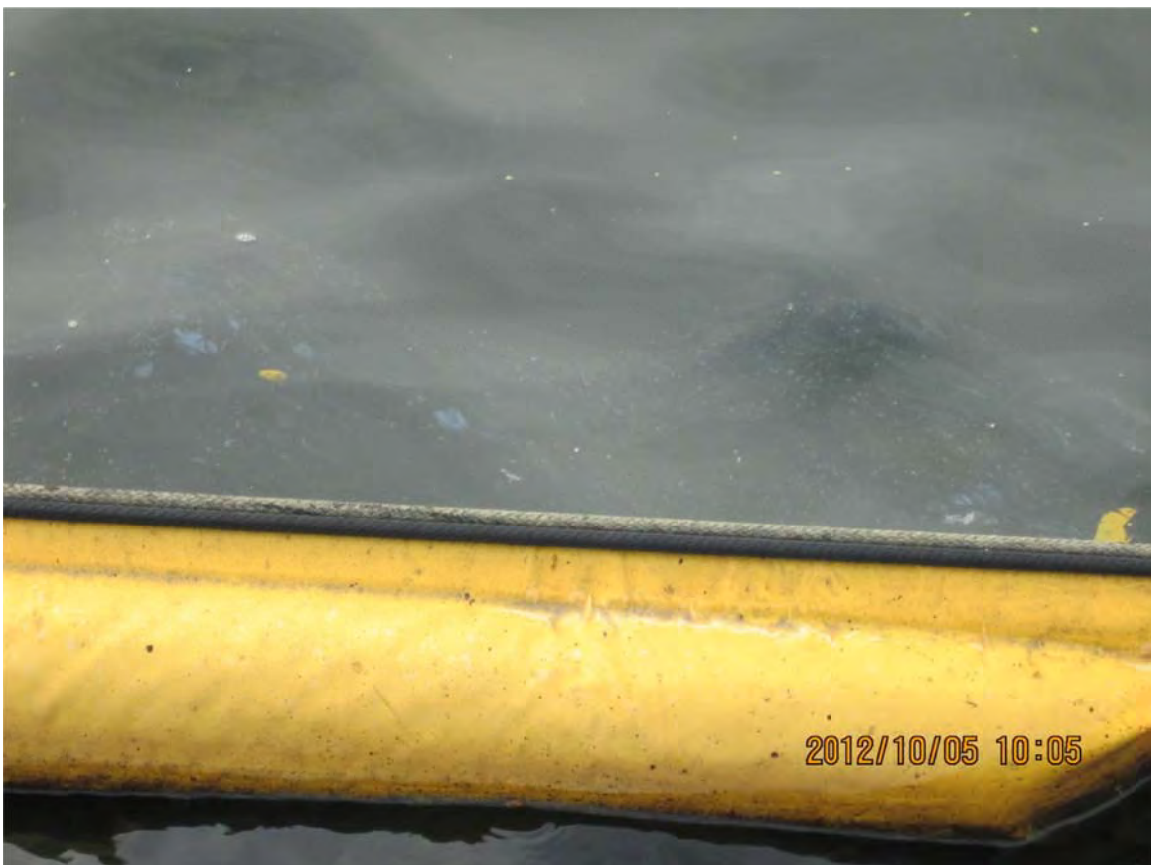
16. Sheen observed along C1 boom in Morrow Lake Delta.

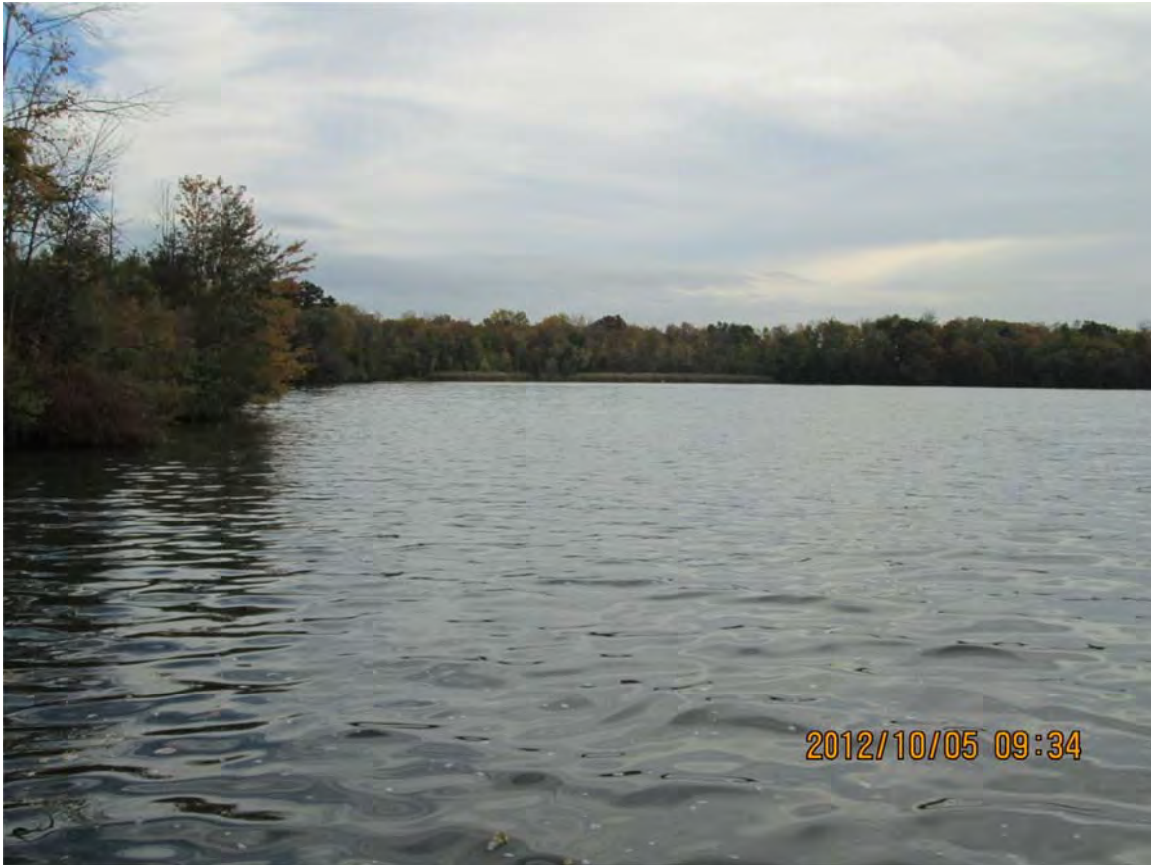
17. North cove on Morrow Lake. No sheen observed in choppy water.

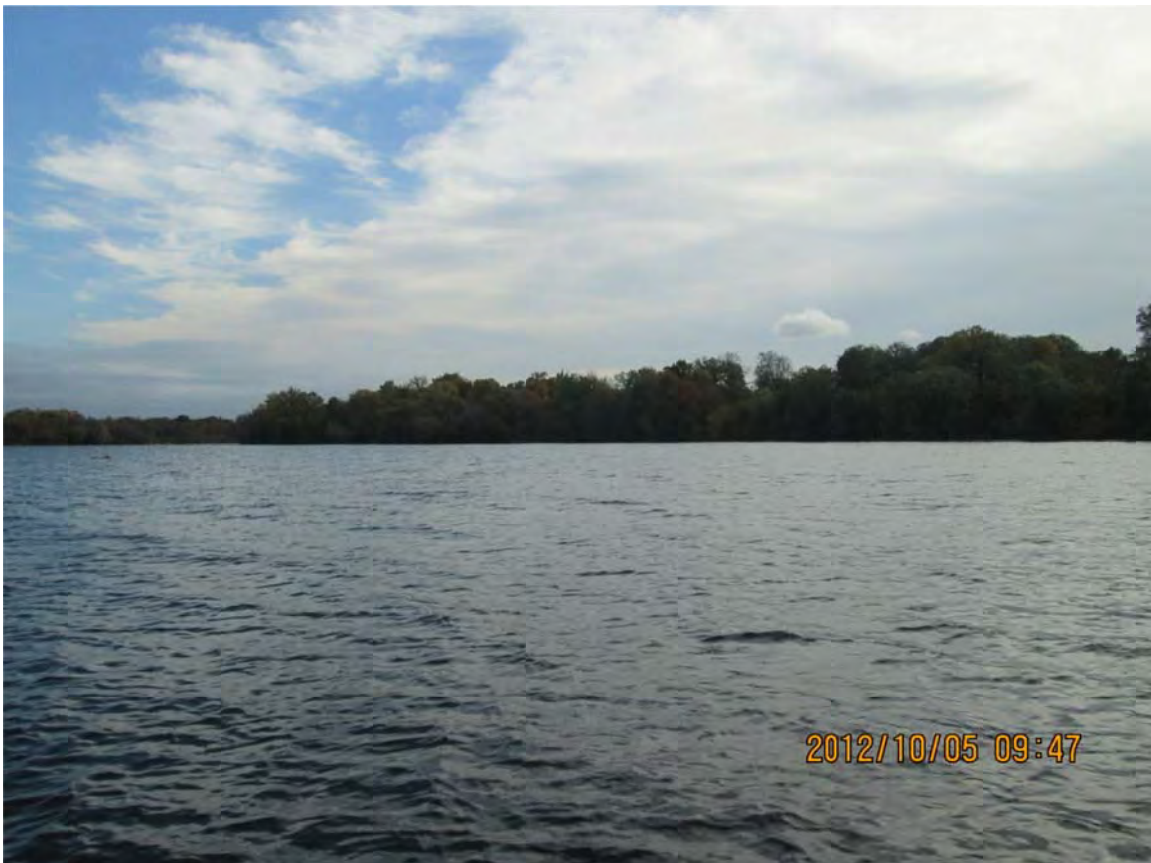
18. South cove of Morrow Lake. No sheen observed in choppy water.
